Wind River Watershed Restoration Project, Volume II of III

Annual Report
1998

Report F: Restoration -- Part I

Report F: Restoration -- Part II

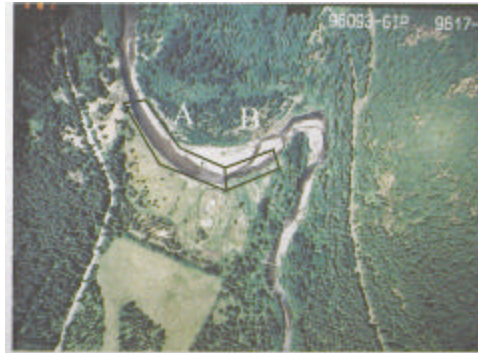
Figure 2. Aerial view of project site. Section “A” was treated with FMF structures in September 1998. Section “B” will be treated with structures in September 1999.

Approximately 1,500 feet of vertical bank was treated by installing twelve instream log structures (identified as section “A” in Figure 2). The remaining 400-500 feet of bank in the project area (identified as section “B” in Figure 2) was excavated to a slope of 2:1 and treated with plantings and erosion control matting. Structure design was derived from similar structures Brian Bair and Paul Powers of the U.S. Forest Service have developed. The design has evolved from structure types identified by Rosgen (1993) and Abbe (1997). These structures have proven effective in similar projects within the watershed. This structure design was also agreed on due to permit requirements and our obligation to preserve the aesthetic values and free flowing character of the river. Rip-rap or bank-barb type structures would not fulfill this requirement.

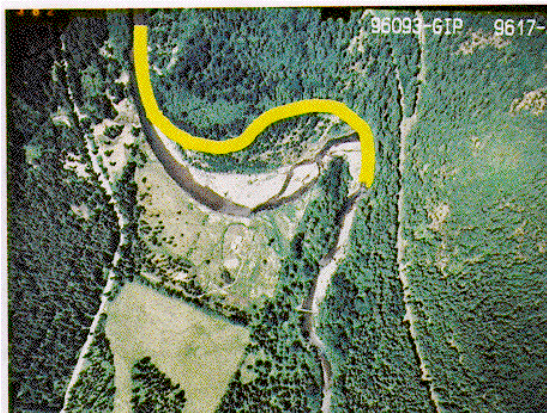
Figure 3. The line imposed on this photo represents where the river channel was in 1949. This line also resembles the length of meander derived from the Williams (1986) equations.

Williams (1986) hydrologic models indicate that the current length of meander is extremely out of balance (see Figures 3 and 4). Lateral channel migration has occurred as a result of the riparian timber harvest in 1940 (and the subsequent loss of bank stability) and increased peak flows resulting from upland timber harvest and road construction. The river will likely adjust to restore an appropriate length of meander. This will most likely occur as a meander cut-off at the lower end of the project reach (Castro 1998) and/or reactivate abandoned channels on the north side of the river. There are several head-cutting relief channels at the lower end of the reach that are active during bankfull events.

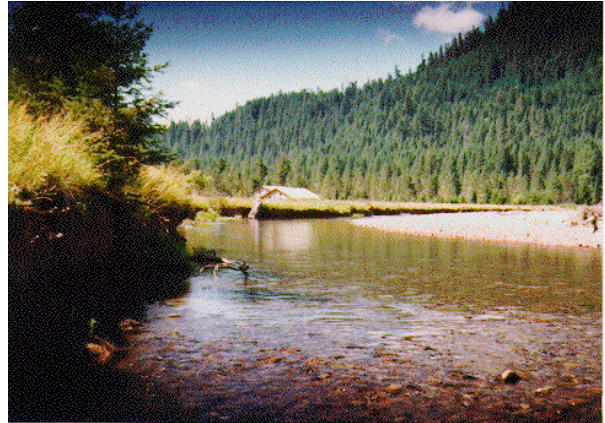
Figure 6. Rapidly eroding cut-bank prior to project implementation, Summer 1997.

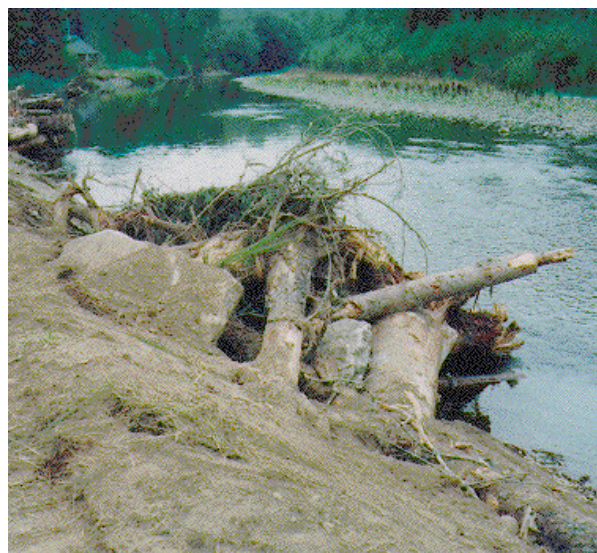
Figure 8. Structure immediately after construction, September 1998.

Structure construction and bank sloping were accomplished by using a 50,000-lb, tracked excavator. The excavator was used to trench into the bank and place the logs and rocks. Due to a shortage in materials we were unable to treat the entire length with large wood. Rather than spread materials thin, we opted to focus the wood in the upper project area, where we would be gaining the greatest benefits. Currently we are planning a second phase of this project. The purpose of the second phase is to treat the final 400-500 feet of bank with wood structures. This lower segment suffered continued erosion during the winter of 1998-1999 high flow events.

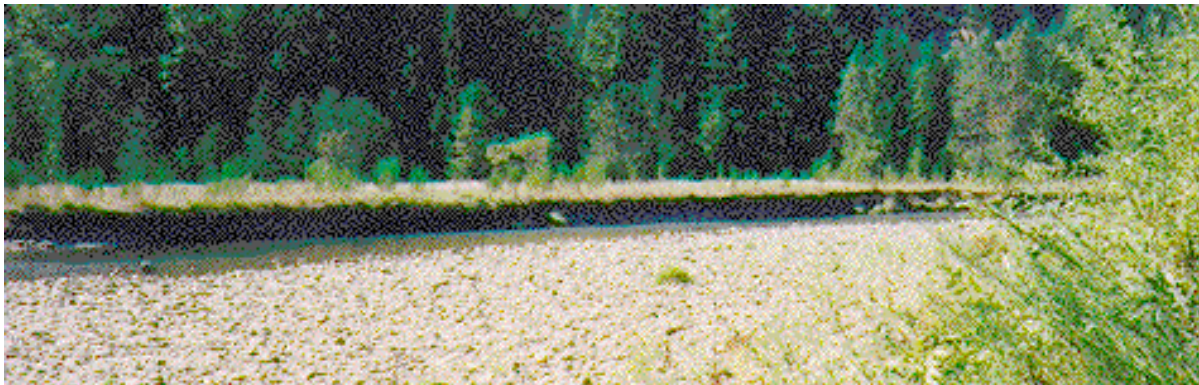
Figure 9. Photo documentation station #2. Before project construction, August 1998.

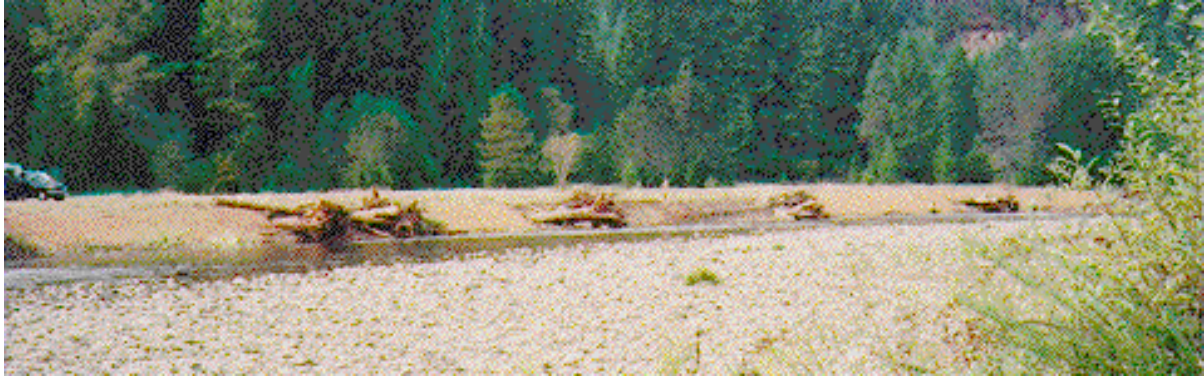
Figure 10. Photo documentation station #2. After project construction, October 1998.

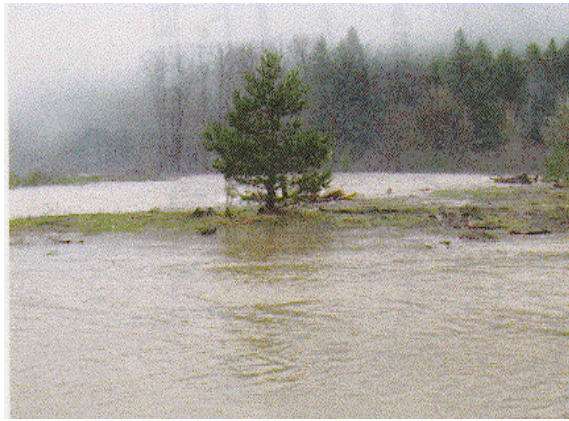
Figure 11. Looking downstream towards the bottom three structures across flooded bank at bankfull flow December 28, 1998.

Since the time of completion, the project has experienced three bankfull flow events (21 Nov 98, 2 Dec 98, and 28 Dec 98). Bankfull flow for this reach of the Wind River is approximately 5,000 cubic feet per second. All twelve structures performed remarkably well. The thalweg was moved away from the riverbank and deposition has occurred between each structure. Lateral bank migration appears to have ceased along the 1,500 feet treated with structures. The areas that have e-mat covered with slash and/or green trees (trees with branches intact), are very successful at holding the e-mat in place and trapping fine sediments. (see Figures 9, 10, and 11) Downstream of the structures, where the bank was pulled back and treated with erosion matting and plantings only, the bank has again become mostly vertical (see Figure 12). This demonstrates that wood is necessary in stabilizing banks within a “flashy” Wind River system. Bank stability for the entire project area has been increased from 5% to 80%. The amount of large woody debris has been increased from less than 14 pieces per mile to over 340 (125 pieces installed / 0.36 river miles), emulating an extensive jam.

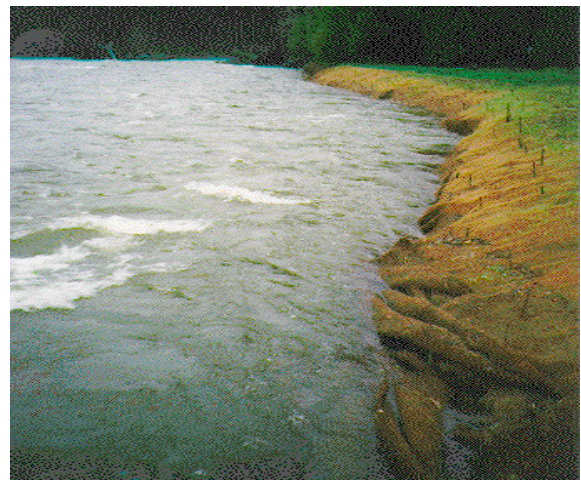
Figure 12. Lower end of cut-bank suffering continued erosion after first bankfull flow event, November 1998.

In March 1999, additional material was added to the structures (see Figure 13). Placement of the material targeted structures that lacked sufficient wood debris to protect the bank interface. Material was also placed in active floodplain channels in order to increase floodplain roughness (Figure 14).

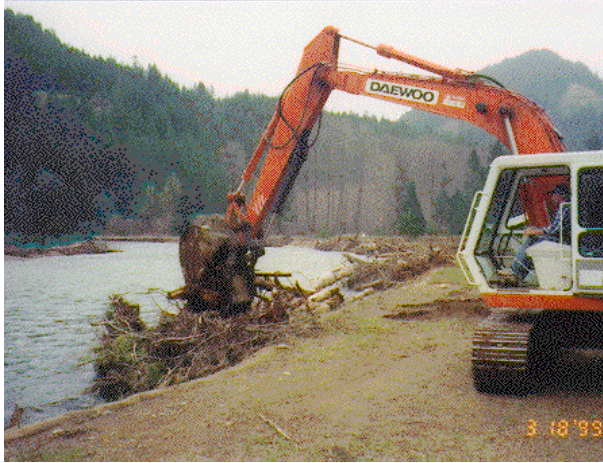
Figure 13. Adding material to structures in March 1999.

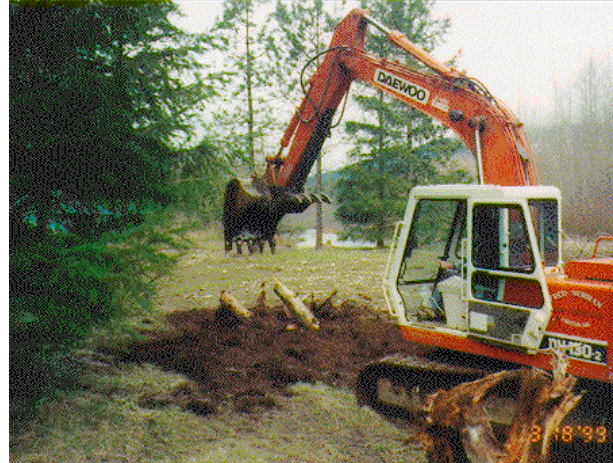
Figure 14. Adding material to floodplain in March 1999.

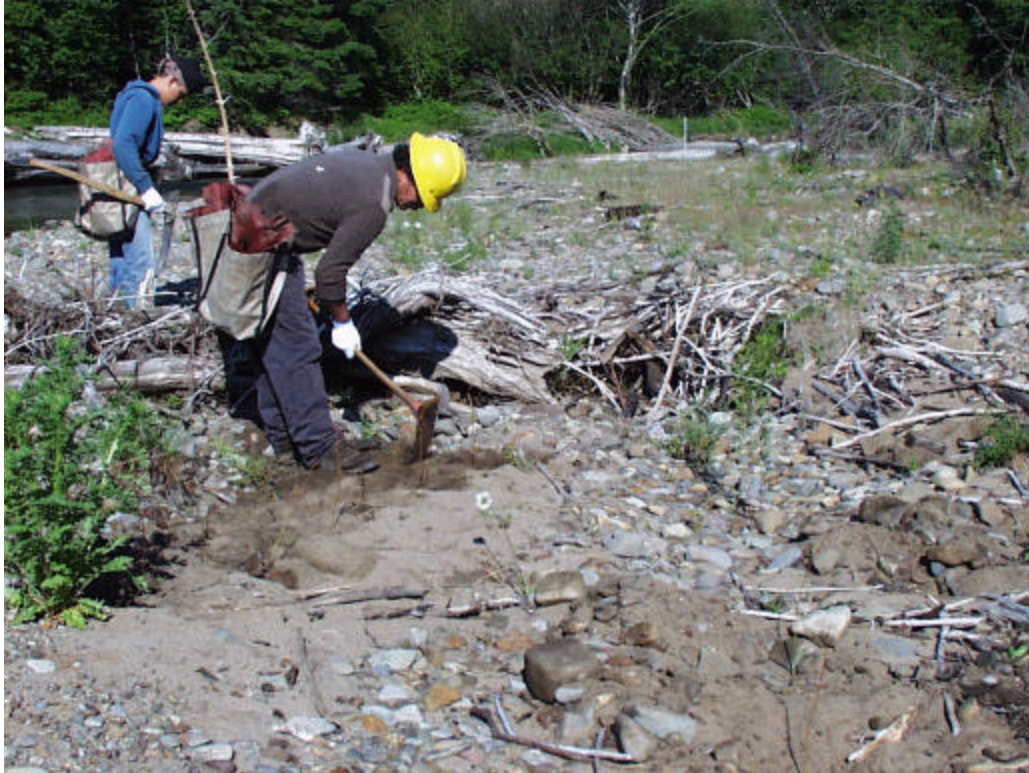
Figure 4. Hand crew planting rooted willow and red alder shrubs in deposition areas along Trout Creek, Skamania County, Washington.

Homogeneous stands of alder and Douglas fir were under planted with native conifers to increase stand diversity and provide a long-term source of large woody debris. Hand crews planted coniferous seedlings on 5 to 10 foot spacing during the spring months. Rooted willow stock was also planted on the lower banks and within the bankfull channel to increase channel stability and increase stream shade.

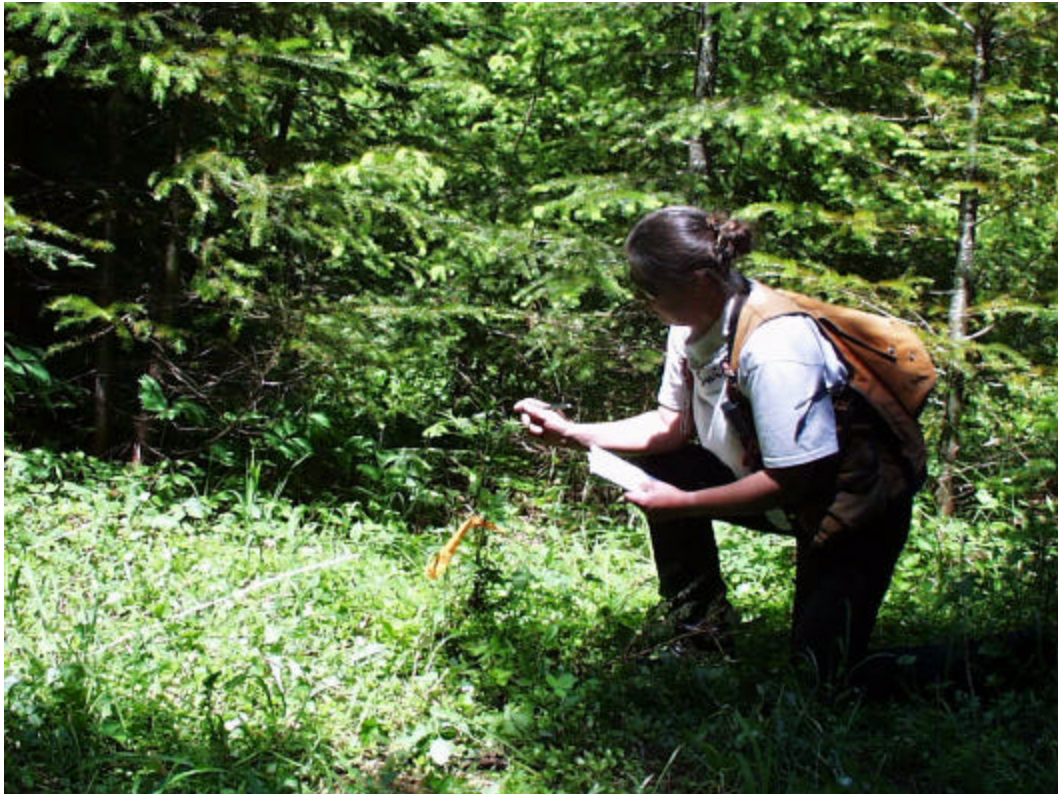
Figure 5. Monitoring survival and growth at plot #2, Layout Creek, Skamania County, Washington.

Survival and growth plots were established for riparian plantings. Survival and growth will be evaluated on an annual basis for the next five years.

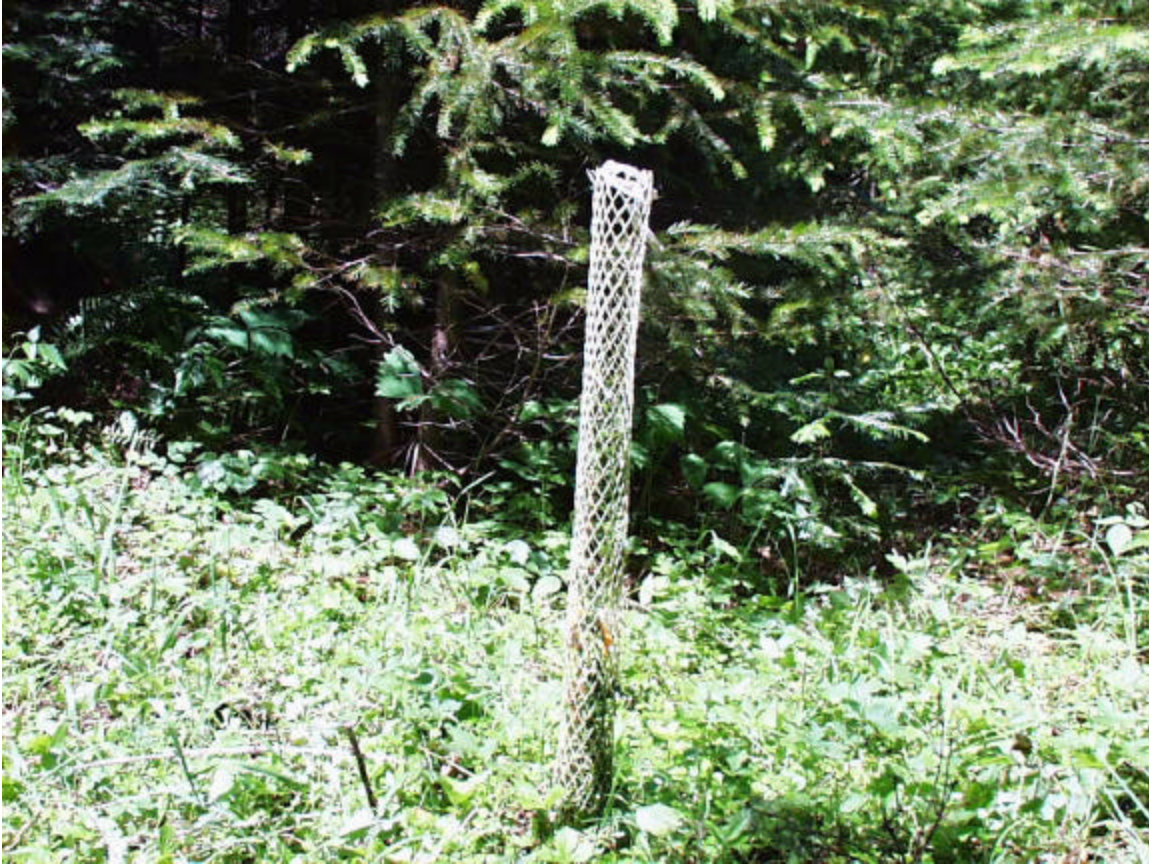
Figure 6. Vexar tubing protecting western red cedar from deer and elk browse, plot #2 Layout Creek, Skamania County, Washington.

In the spring of 1998 46 acres along the Middle Reach of the Wind River were thinned and 17 riparian acres were under planted with 6000 grand fir and 2000 white pine along Crater, Compass and Trout Creek to diversify species and seral class. In 1994 the same area was planted with western red cedar and western hemlock within 200’ of the low flow channel. The trees were planted at relatively high densities due to past monitoring within the watershed showed that mortality typically exceeded 60%. Mortality was attributed to browsing, floods and competing vegetation. To reduce mortality associated with browse, flexible nets and vexar tubes were placed on the more palatable species such as western red cedar.

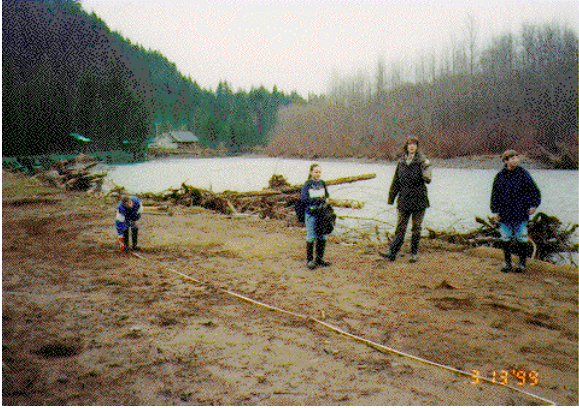
Figure 1. Wind River Middle School JETS students conducting monitoring of Stabler project, Spring 1999.

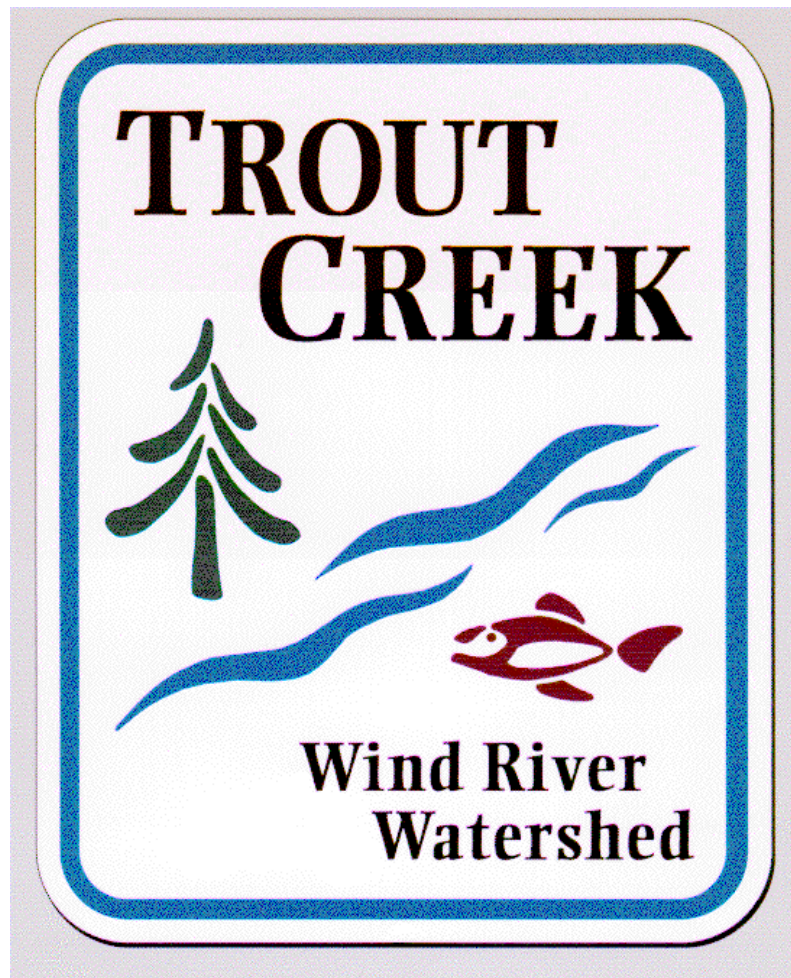
Figure A-1 depicts an example of a sign design. The logo is adapted from the Wind River Watershed project logo that was drawn by a Wind River Middle School student. Five of the signs will be 24” x 30” and 23 of the signs will be 18” x 24” non-reflective aluminum with vinyl or painted lettering. Most of the stream crossings consist of two signs, one facing each direction of travel. The watershed boundary signs are one directional, indicating entry into the watershed.

Figure A-1. Example of a sign design for watersheds within the Wind River drainage.
